Drinking water 2018

Quarter 1

A report by the Chief Inspector of Drinking Water

Drinking water 2018
Public water supplies for
England and Wales

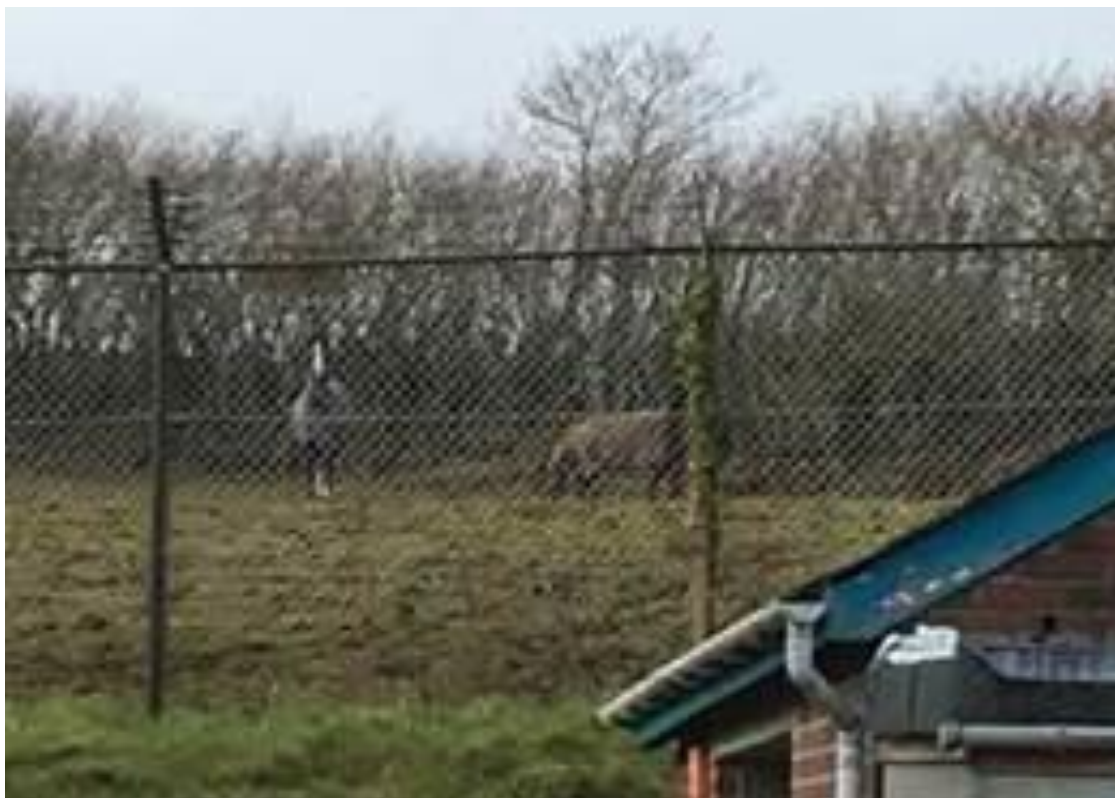
Conversely, South West Water's Houndall reservoir is situated below a field containing horses. Inevitably there is manure in the field and there is a risk of surface water runoff into chambers on site and onto the reservoir roof. The risks had not been recorded in the site's drinking water safety plan risk assessment and the failure to identify risks beyond site boundaries appears common to many of the company's sites.

Figure 1: Horses in field above South West Water's Houndall Service Reservoir

Recommendations were made for both Wessex Water and South West Water to review risk assessments for all service reservoirs.

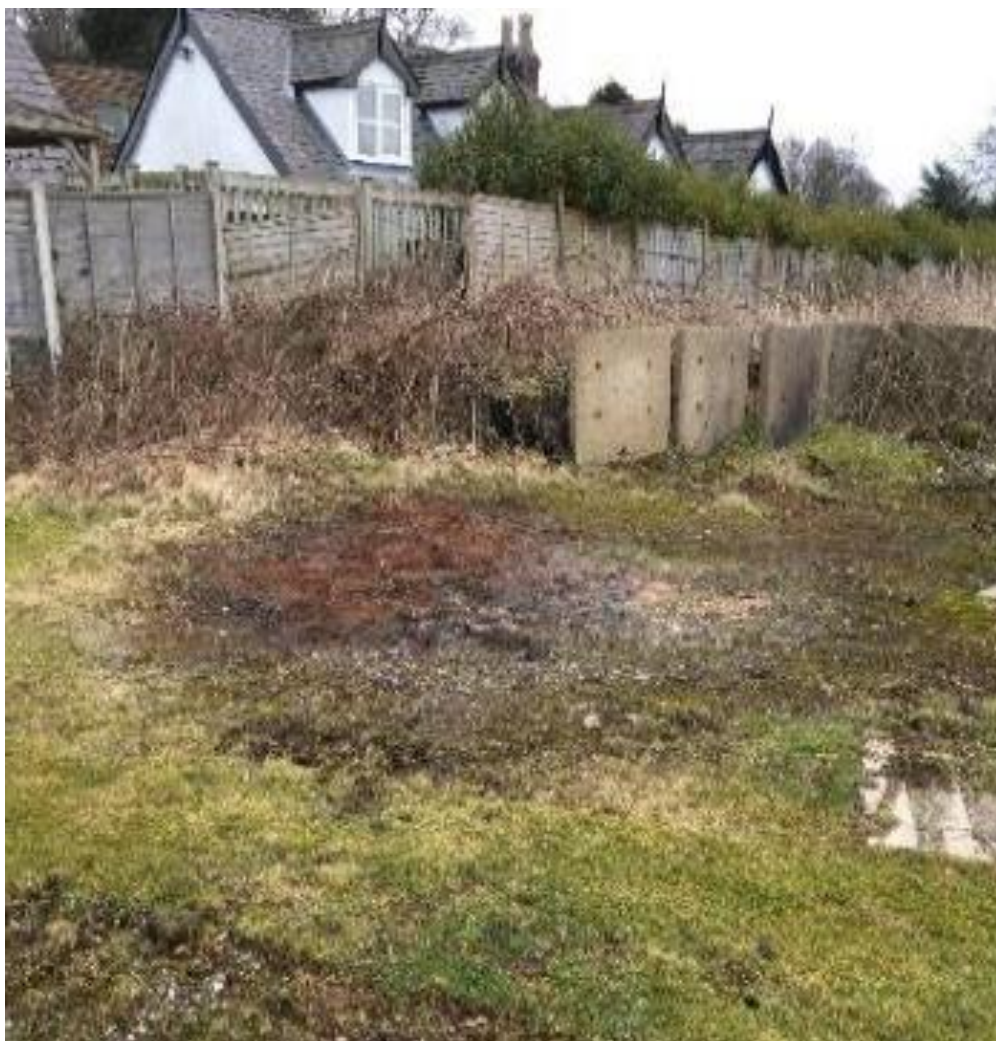
There were a number of houses which backed onto the land adjacent to United Utilities' Pex Hill reservoir, it appeared that some of the local residents had used land within the grounds of the reservoir approximately 10m from the edge of the reservoir as a place for a bonfire. The company need to do more to prevent intruders using the site.

Figure 4: Bonfire site in the grounds of United Utilities Pex Hill SR

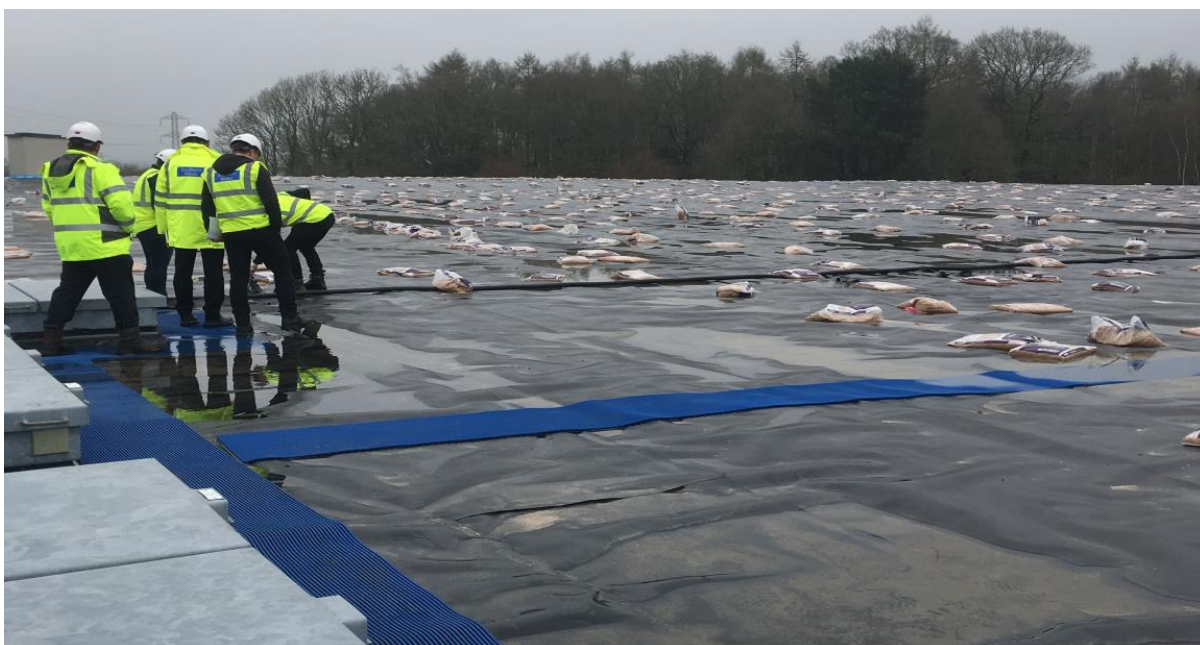
Figure 5: Rownhams Reservoir. Temporary Cover.

The roof of Southern Water's Rownhams Reservoir is in a vulnerable condition. Following the detection of ingress the company decided to install a temporary membrane over the grass. The temporary membrane was held down by sand bags. There was heavy rain the night before the audit, and water was pooling on top of the membrane. A small section was lifted to examine the soil condition, which was damp but not waterlogged. It is likely that the membrane has provided some protection from further ingress following heavy rain. Whilst the over membrane has provided some reduction in ingress, it has not prevented it. The risk to consumers was not adequately mitigated. The Inspectorate subsequently issued a notice to rectify the structural issues found at this site.

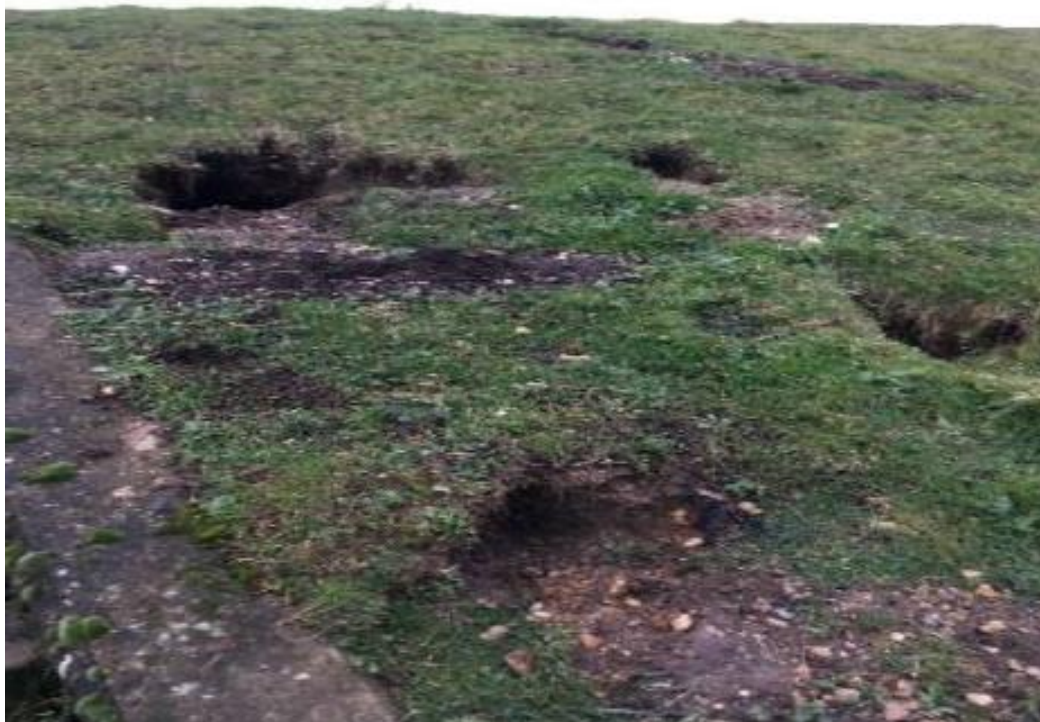
All but one of the Affinity Water service reservoir sites visited appeared to have signs of significant vermin activity. Animal holes ranged from numerous small holes on the top of the service reservoirs to more substantial burrow holes in the banks to the service reservoirs. This was especially noticeable at Jack's Hill and Sibleys Old service reservoir. The external inspection reports for these sites highlighted the animal activity as an action to address. The Inspectorate concluded the company does not have robust control measures in place to address vermin activity and recommended the company takes steps to control vermin and ensures there is clear reporting, accountability and review of actions taken to ensure the objectives are achieved.

Figure 6: Jack's Hill SR – Vermin burrows into the embankment

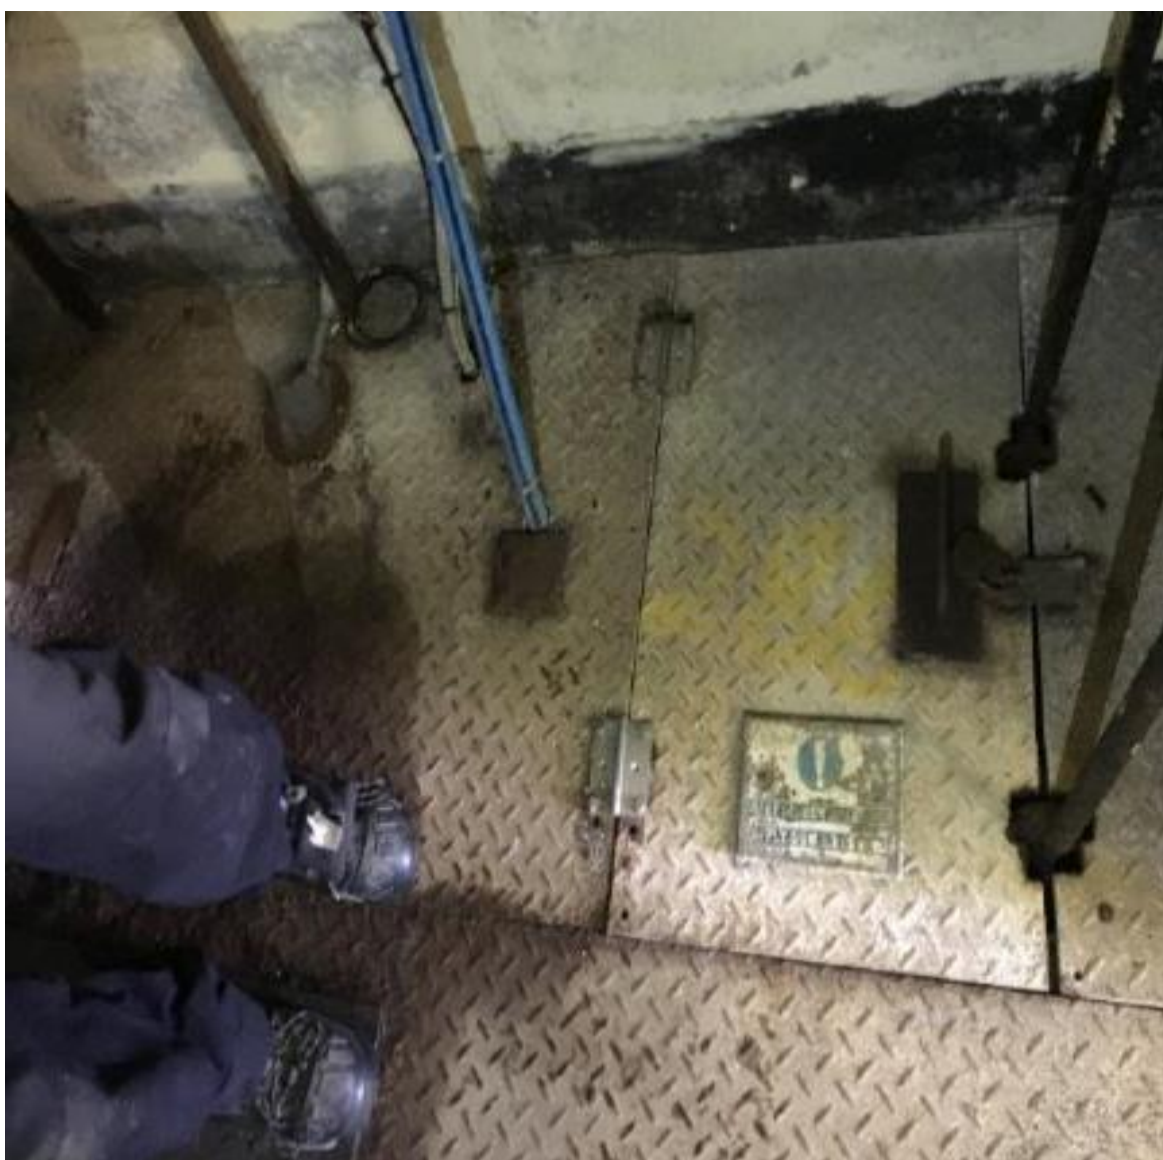
Figure 7: Poor integrity of sample hatch at United Utilities Runcorn service reservoir

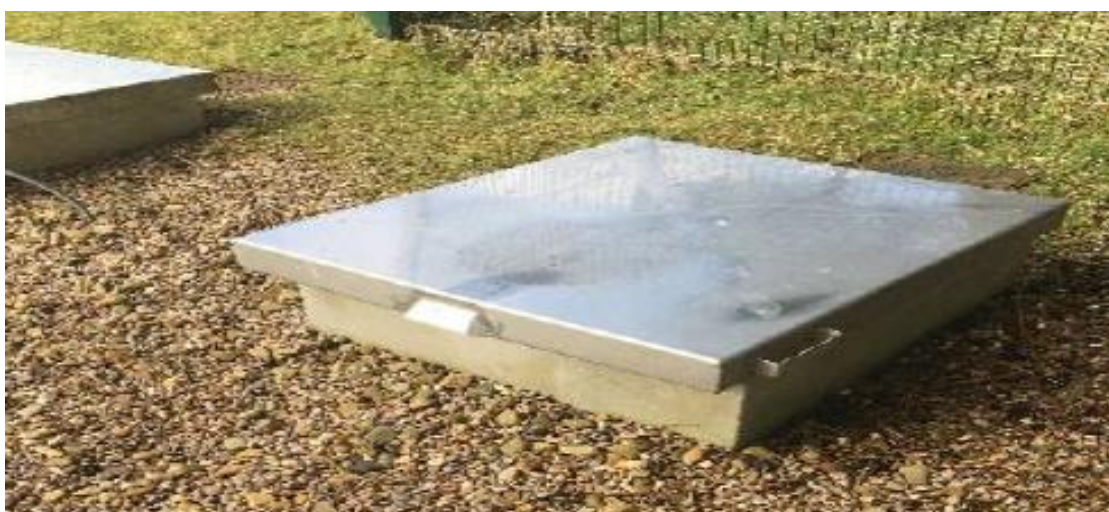
Service reservoir hatches were observed to be in good condition at Yorkshire Water's Thornseat reservoir, locked with a high security padlock and fit-for-purpose. All outer hatches are vacuum cleaned before the inner hatch is opened, this is good practice.

Figure 8: Hatches in good condition at Yorkshire Water's Thornseat service reservoir

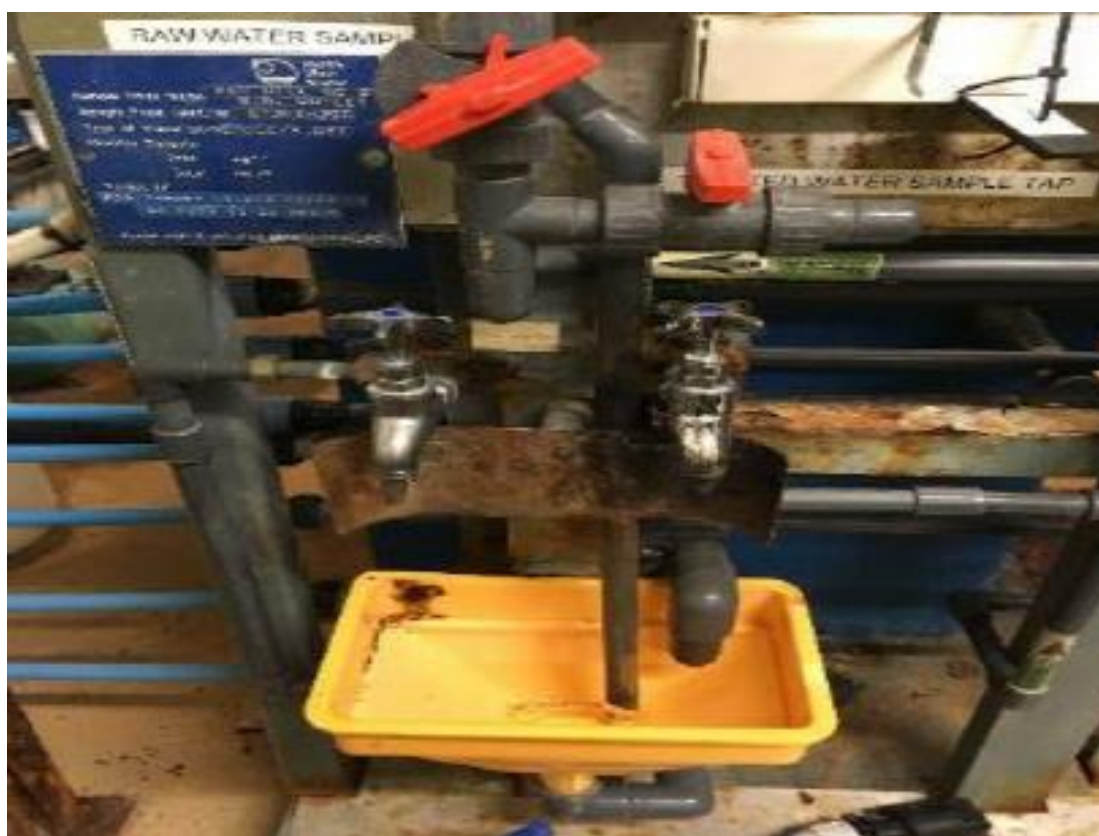
There were several examples of sample taps that were not dedicated tappings. An example is shown at United Utilities Pex Hill service reservoir which is not tapped onto the outlet main (Figure 9), but was connected via the booster chlorination system and also has the triple validation residual chlorine monitors connected to the same point. A similar situation exists at Runcorn service reservoir.

Figure 9: Non-dedicated sample line at United Utilities Pex Hill SR

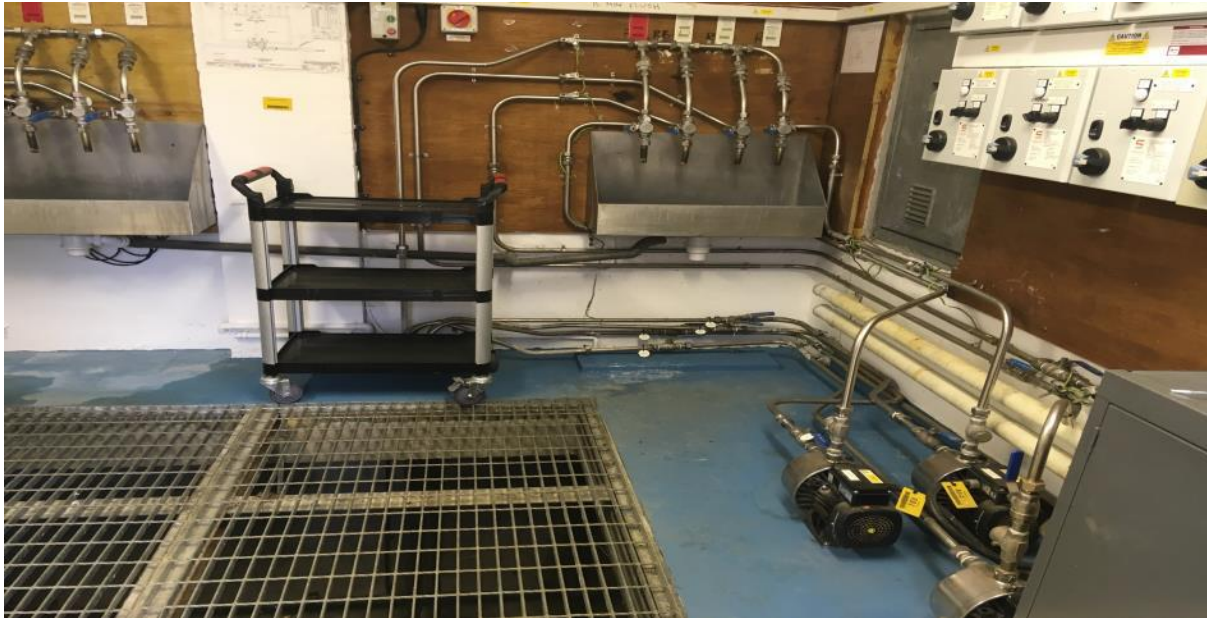
All Thames Water sites inspected on the day were found to be in generally good order. The sampling facilities were located in secure kiosks. The sample taps were situated in a clean working area marked out in blue. The sampling facilities were appropriately labelled with instructions for samplers clearly visible (Figure 11).

Figure 10: Clean working area by Thames Water sample point

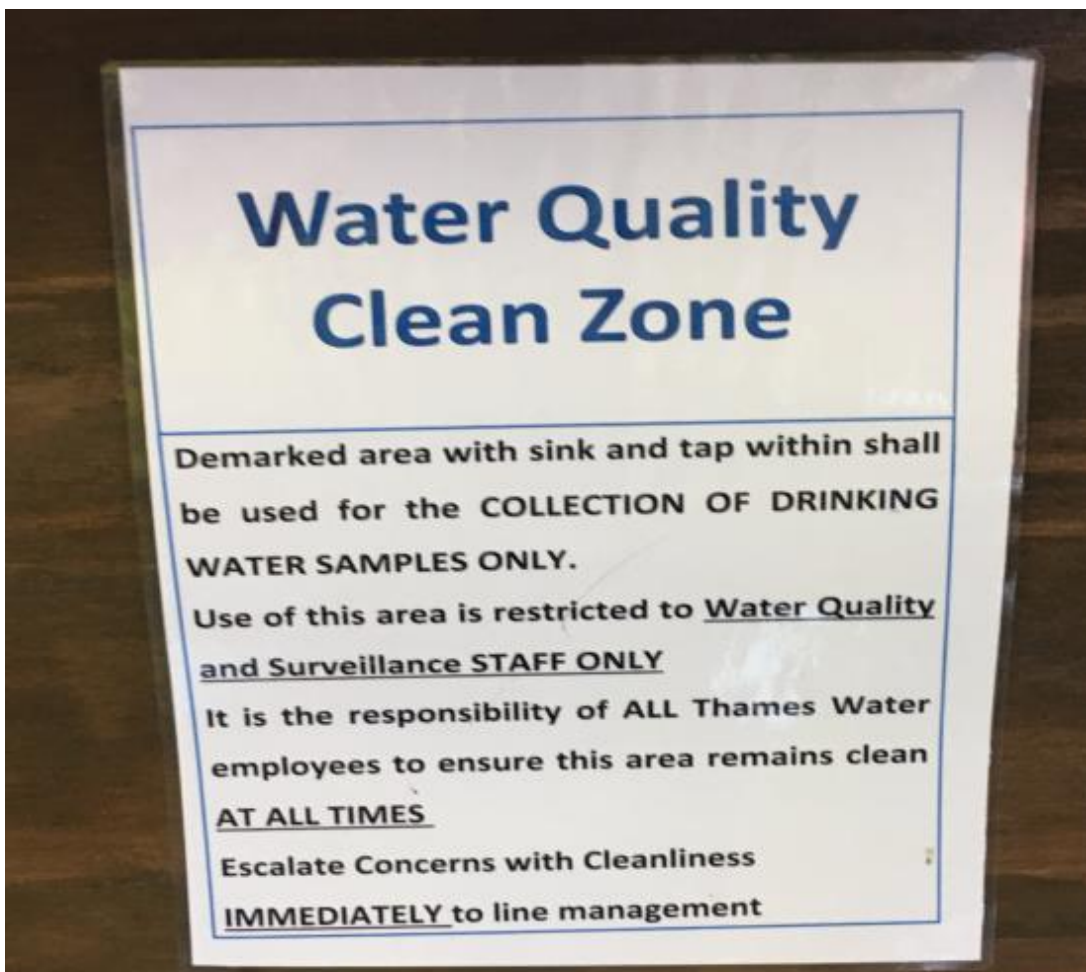
Figure 11: Clear instruction for samplers
